Updates and Plans for the Earthscope Alaska Transportable Array - 2016

Ryan Bierma
Station Specialist/
Field Ops Manager

*Polar Technology Conference
Littleton, CO
21-22 March, 2016*

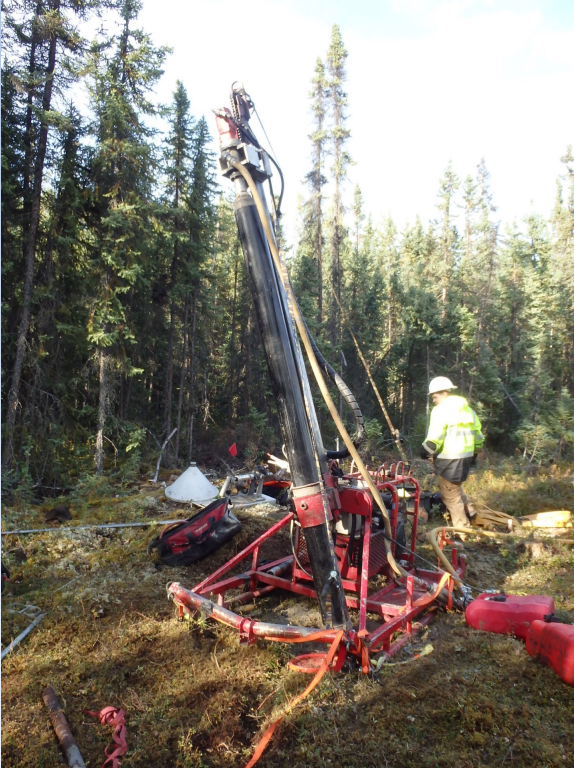
Broken drill rig at I26K

- Drilling complications – overheating, misfit gearing between compressor and motor, wear and tear.
- Wrinkles in Year 1 of the Genasun LiFEPO4 (LFP) and customized charge controller. Main issue was an internal battery switch. Issues with enclosure humidity causing corrosion on batteries.
- Worst Alaska forest fire season since 2004, ~5.5 million acres burned. 1 site lost.

- New robust drill rig built - tested and en route to Alaska for initiation
- Engineering improvements with power system, especially LFP batteries, should yield better results— a more robust component swapped in and efforts to create a more suitable environment for batteries.
- Similar winter as 2015 – another bad fire season a real possibility.

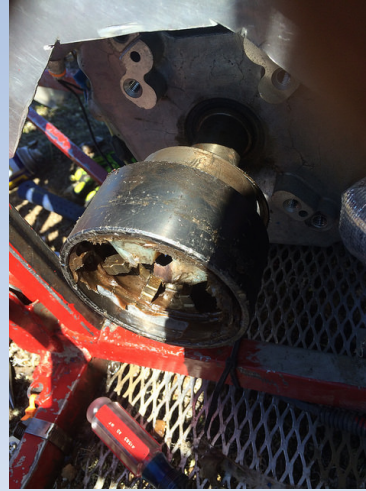
Broken spider gear
due to engine/
compressor
gearing mismatch

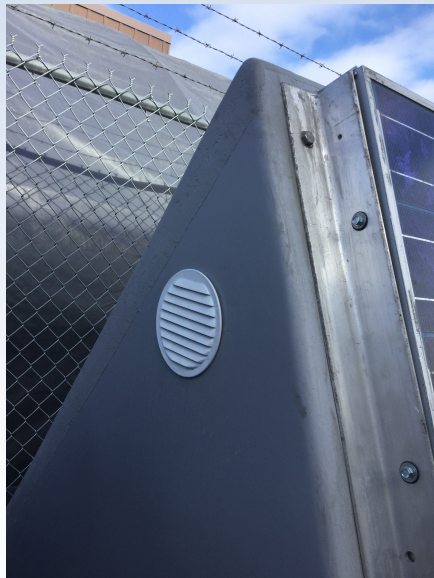
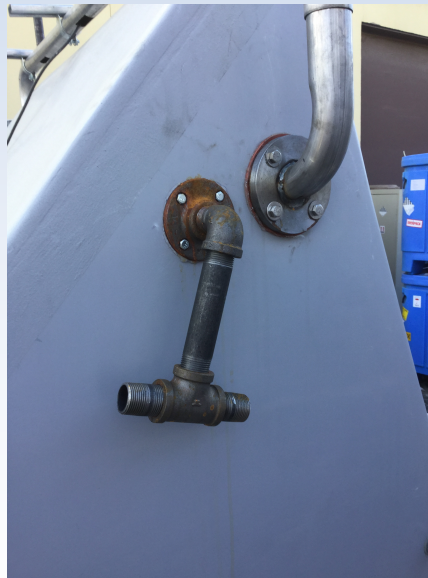
Gore Vents
?

Problem 2: Humidity inside enclosure huts appears to be causing corrosion on PCB inside LFP batteries.

Solution:

Improve venting on huts (in development).

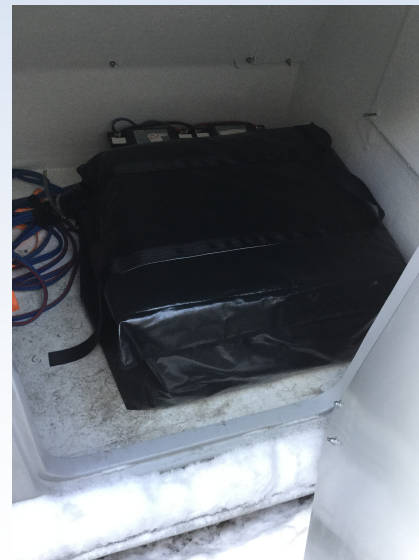
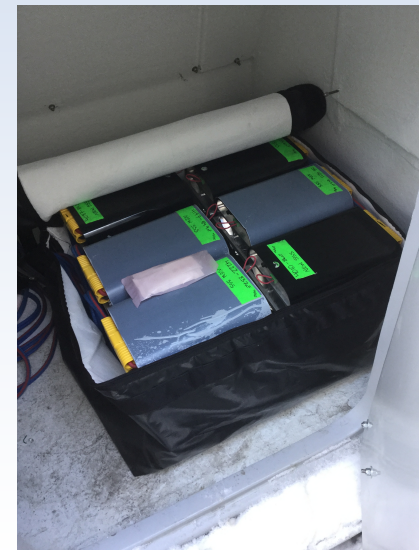
Problem 2: Humidity inside enclosure huts appears to be causing corrosion on PCB inside LFP batteries.

Improve venting on huts (in development).

Install LFP batteries inside a moisture/vapor resistant bag.
