# Using High-Resolution Satellite Imagery and Ground Penetrating Radar to Avoid Crevasses Along the Greenland Inland Traverse (GrIT) Route

Jennifer Mercer, Amy Burzynski, Elias Deeb, Steve Newman  
US Army ERDC-CRREL

8<sup>th</sup> Polar  
Technology  
Conference  
Fairlee, VT  
April 2012

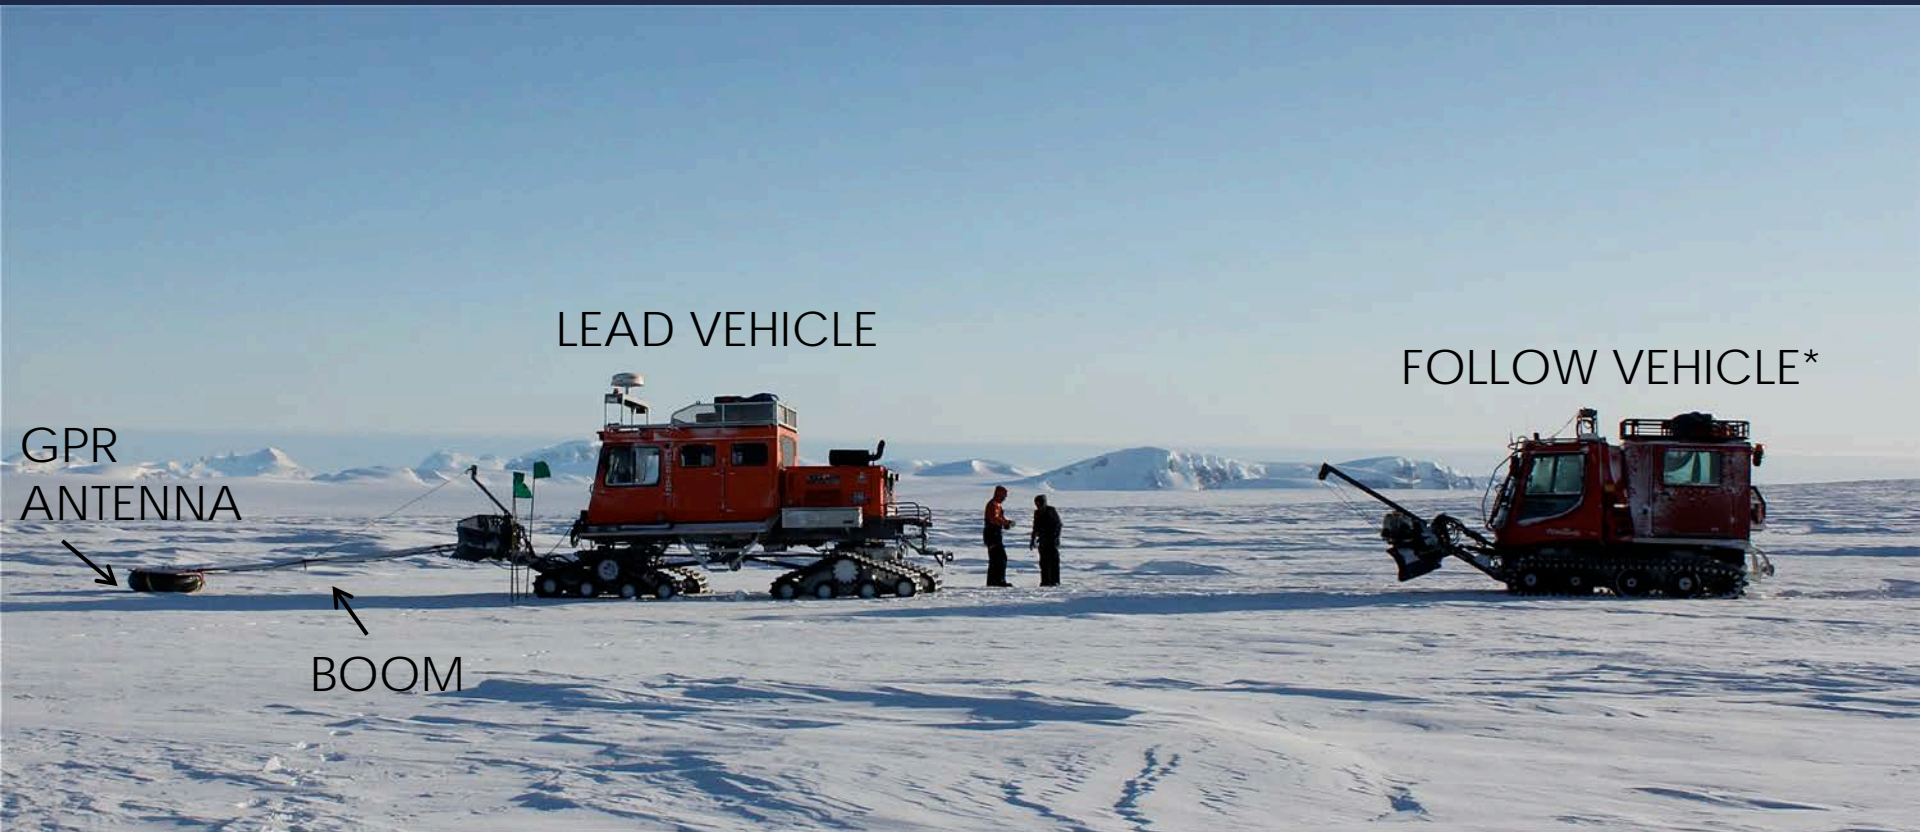
STEP 2:  
-Using GPR and a Strategic Crevasse Avoidance Team, Ground-Truth and Install Route

\*In Previous years, follow vehicle was a snow mobile

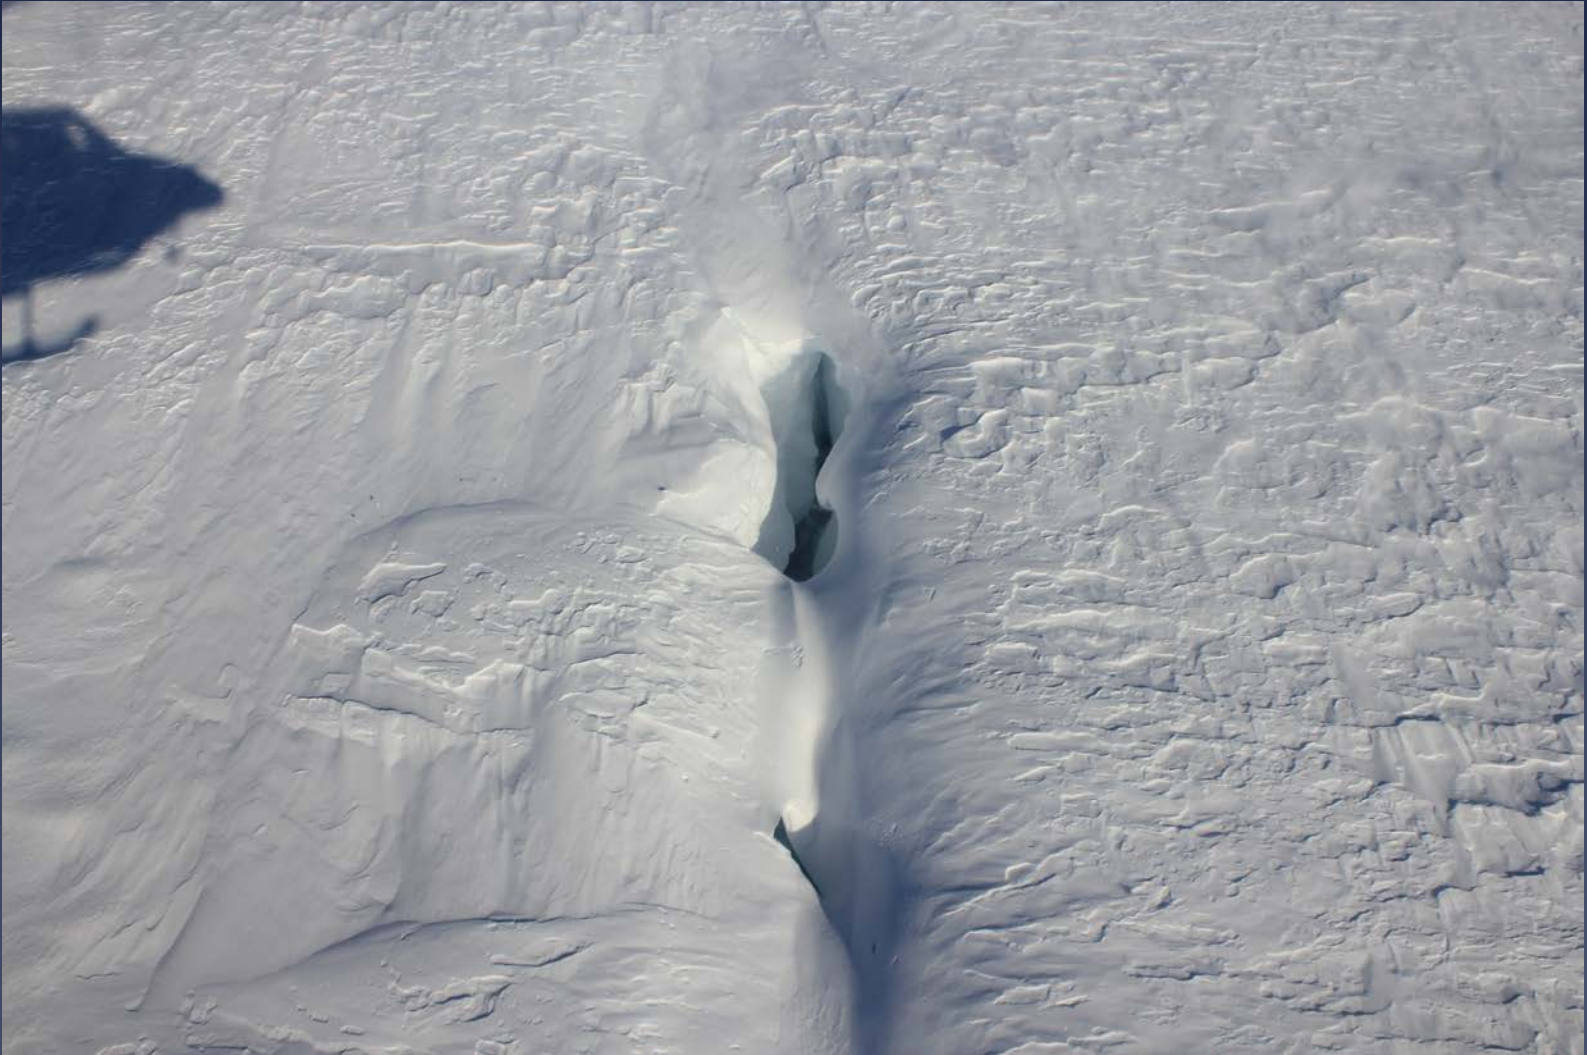
- Drifting fills sections of voids and then bridges the crevasse
- Crevasses are v-shaped, can have multiple bridges and extend to depths of 30-50 feet
